## **Floating Wetlands at Seletar Reservoir by Enviro Pro/ September 2009**

The following photos were taken on September 8, 2009, approximately one year after initial installation of the Floating Wetland was completed. For the last six months, Enviro Pro has not conducted routine maintenance of the floating wetlands.

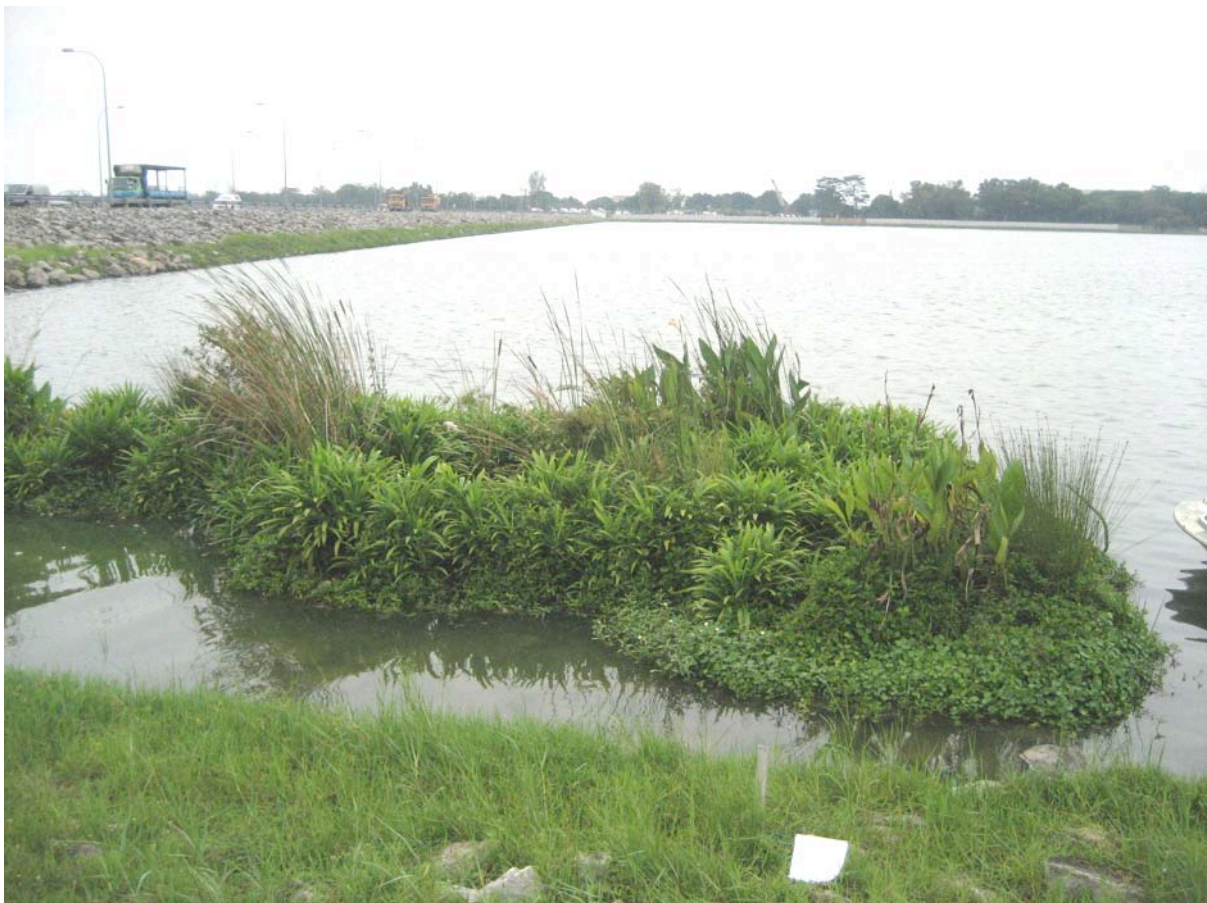
### **Figure 1: Overall status of the Floating Wetland**

Note that as per design intent a natural shaped, free-forming floating wetland was achieved, with diverse vertical strata, including low groundcover along the wetland edges, medium shrub layer and high emergent plants. This gives the floating wetlands structure, depth and a diverse aesthetic look.

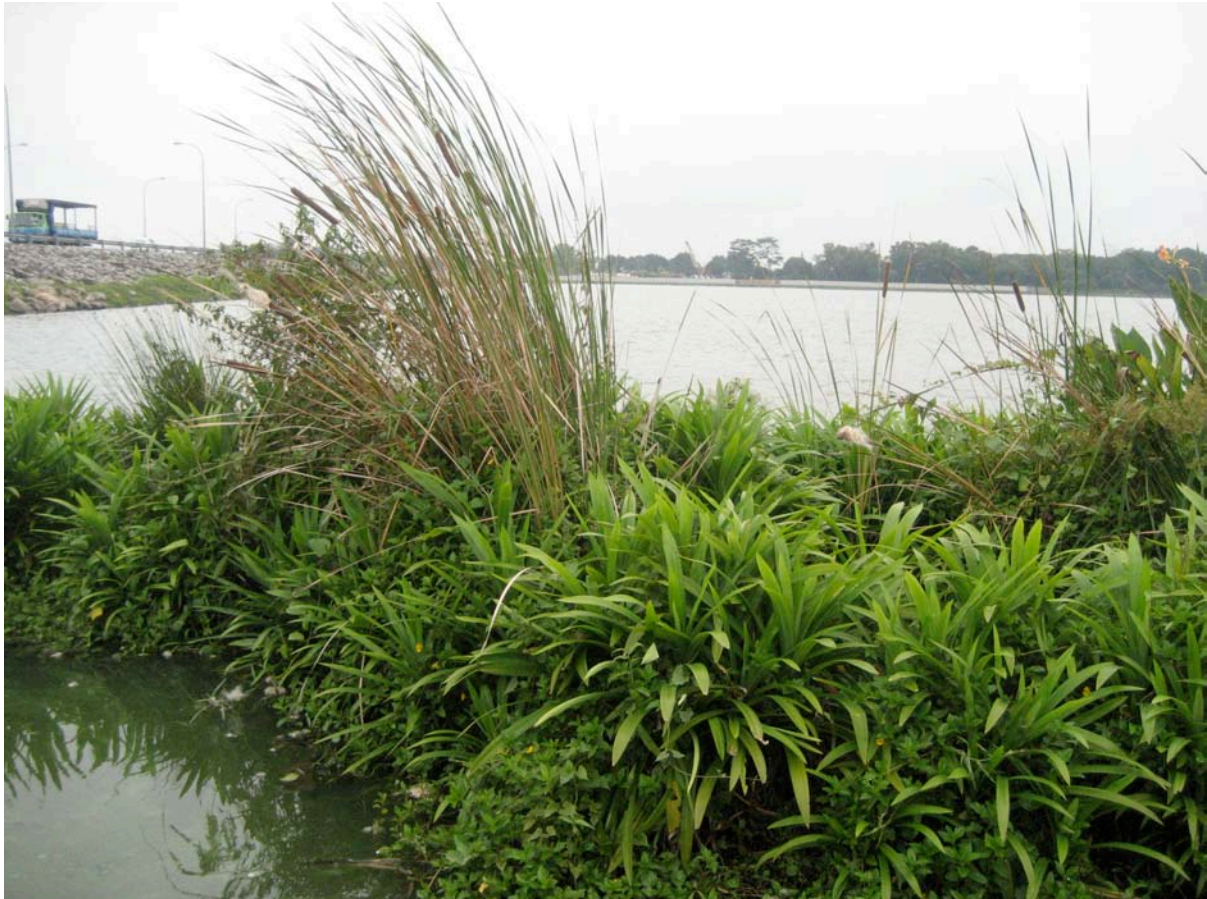
## Figure 2: Close Up of the Floating Wetland

Note that floating wetland plants have established well, with natural succession setting in, bringing new plant species to the Floating Wetland. Without maintenance, dead plant material is left to decompose and provide nutrients and substrate for new shoots and plants to grow.

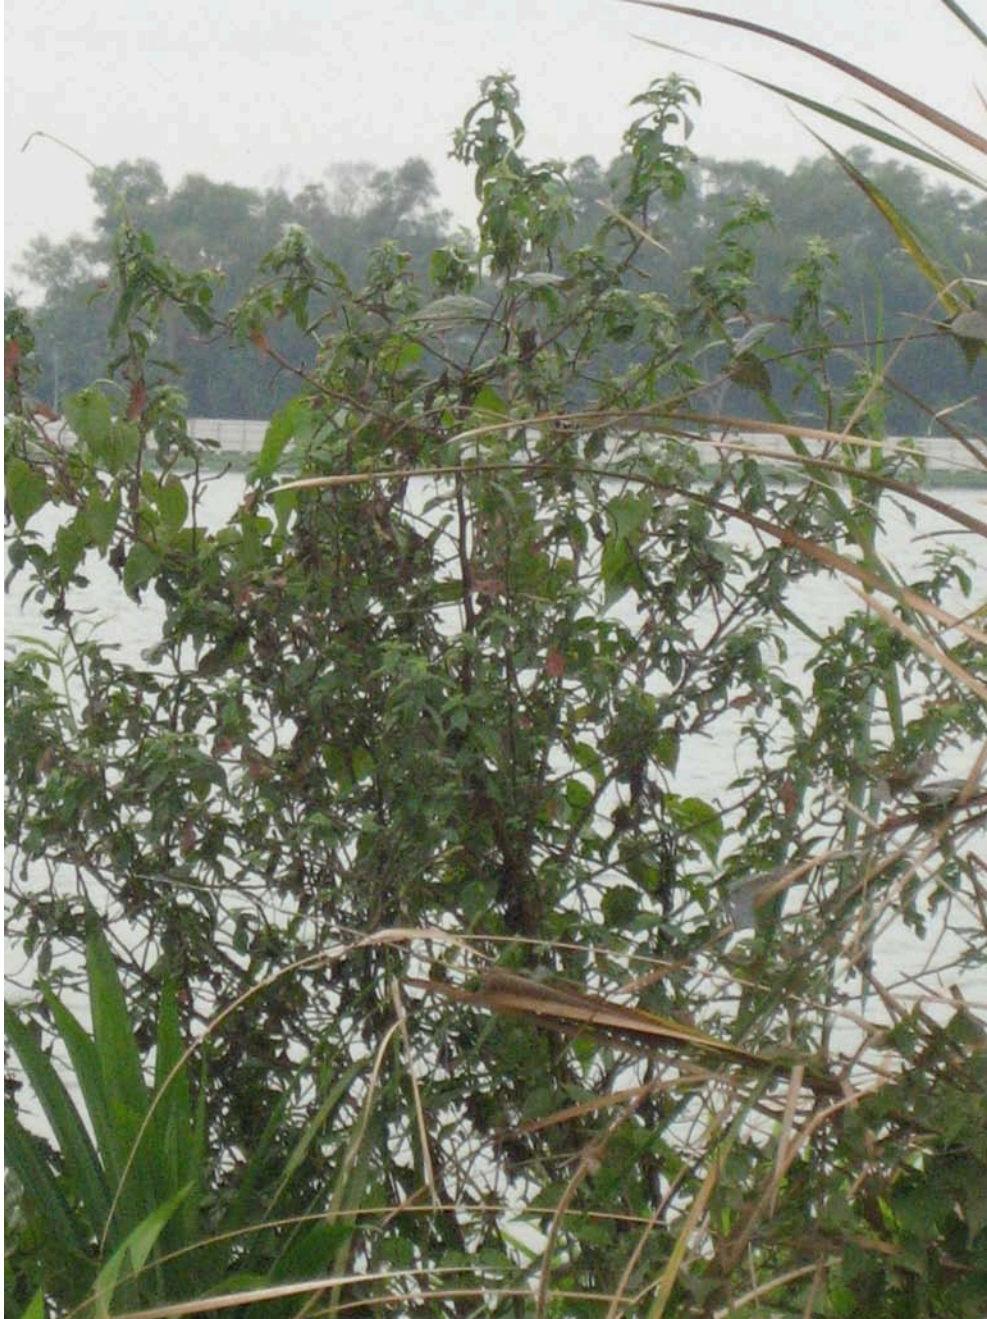
**Figure 3: New Species Established on the Floating Wetland**

This plant species has established itself on the Floating Wetlands, showcasing that also woody shrubs can grow on the Floating Wetlands.

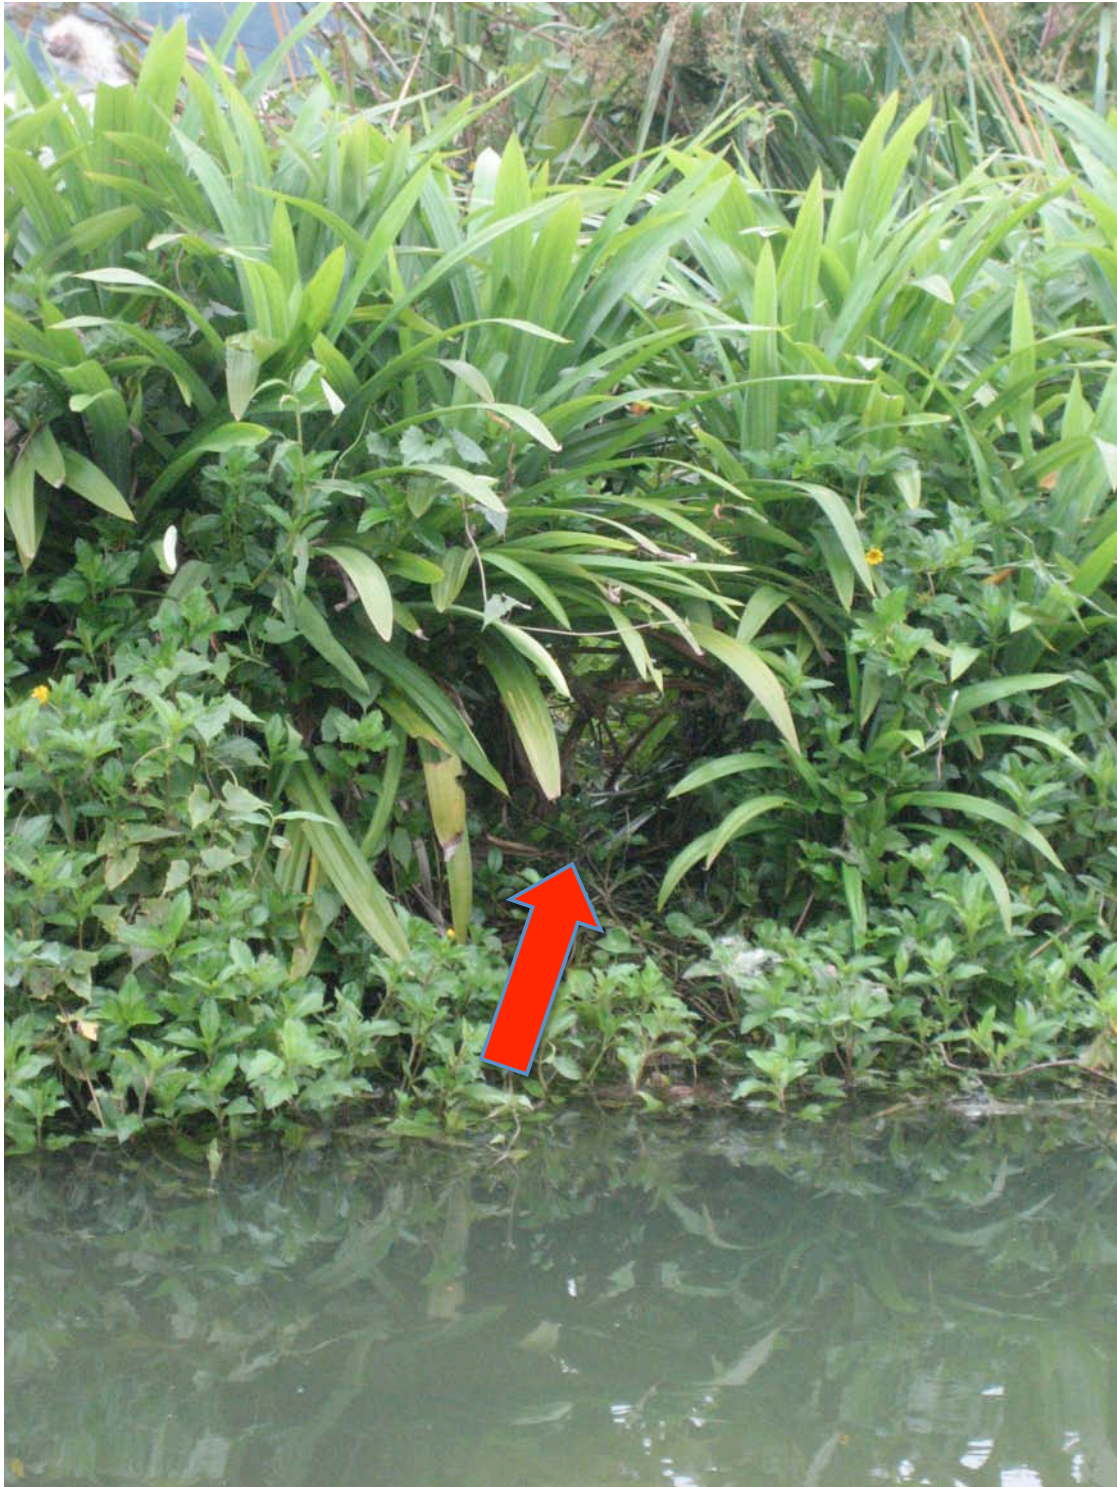
**Figure 4: Habitats on Floating Wetland**

Dense plant layers on the Floating Wetland, blocking the views to a sheltered wildlife roosting site (not shown). Wildlife has created an entrance/exist point to the Floating Wetland, indicative of the acceptance as regular habitat for water dependent species such as birds, monitor lizards and other species.
